## PREVENTIVE MAINTENANCE INSPECTION PLAN FOR SQ-SERIES SERIES SMITH PUMPS

This bulletin is a supplementary addendum, which must be read in conjunction with Technical Bulletin "AL-19". All information listed herein, is in the same numbered section order as detailed in "AL-19". It is applicable to SQ-Series pumps, as well as medium and high capacity Smith pumps, with the exception of what is stated, below. Always disassemble and reassemble the pumps in a safe, approved manner following instructions applicable to these models in other pertinent literature, such as "AL-1", "AL-17A", "AL-45" (N<sub>2</sub>O), "AL-93", "AL-97", "AL-99", "AL-201", and "GM-1". Reseal the casings properly. Contact the factory if there are any questions.

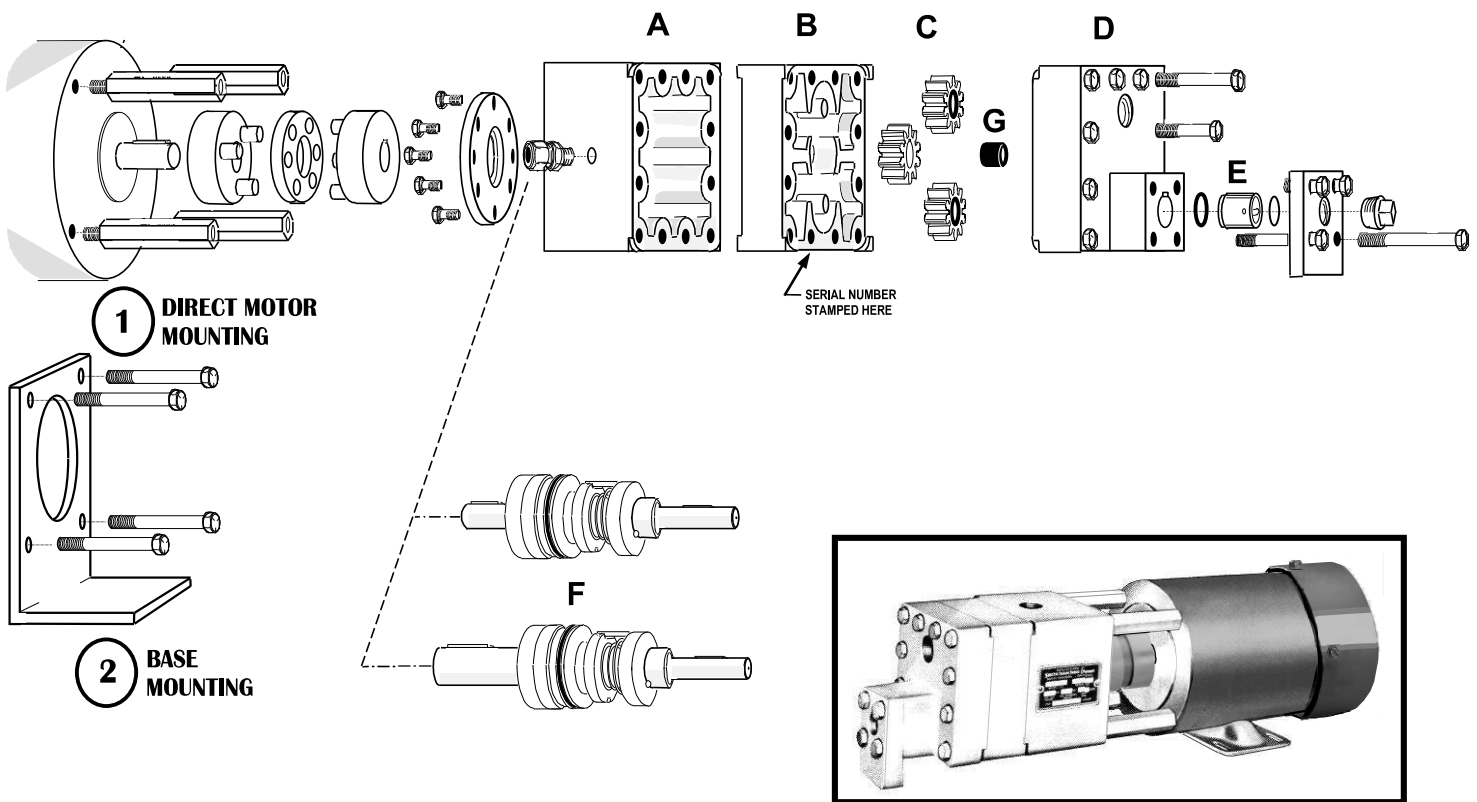
SMITH "SQ-SERIES" PUMP MOUNTED TO A FRACTIONAL HP MOTOR

3. **Inspection of Idler Gear Bushings.** SQ-Series pumps each have two idler gears per set (C) as illustrated on the following page. The proper i.d. of the carbon-graphite idler gear bushings in all idler gears after installation is 0.378 inches (9.60 mm.). If the sizes as measured do not exceed 0.379 inches (9.625 mm.), there has been very little wear and the bushings need not be replaced. If the sizes as measured exceed 0.379 inches (9.625 mm.) after such a short first interval of use, it will be important to examine the piping system and its operation to find the cause of such wear, which is excessive. When the idler gear bushings have worn to a diameter approaching 0.381 inches (9.68 mm.) or greater, the complete gear set must be replaced.

5. **Recommended Procedure if Excessive Gear Wear is Detected.** No Changes.
6. **Inspection of Idler Gear Shafts.** The proper diameter is 0.375 inches (9.53 mm.). If the measured diameter of a worn area is less than 0.374 inches (9.50 mm.) the shafts, assembled in (B) on the following page, must be replaced.

10. **Later Inspections.** No changes. Add "AL-31", and "AL-34" to the list of recommended literature. Check for subsequent casing wear in items (B) and (D) in the illustration, below.
