PREVENTIVE MAINTENANCE INSPECTION PLAN FOR SQ-SERIES SERIES SMITH PUMPS

This bulletin is a supplementary addendum, which must be read in conjunction with Technical Bulletin "AL-19". All information listed herein, is in the same numbered section order as detailed in "AL-19". It is applicable to SQ-Series pumps, as well as medium and high capacity Smith pumps, with the exception of what is stated, below. Always disassemble and reassemble the pumps in a safe, approved manner following instructions applicable to these models in other pertinent literature, such as "AL-1", "AL-17A", "AL-45" (N₂O), "AL-93", "AL-97", "AL-99", "AL-201", and "GM-1". Reseal the casings properly. Contact the factory if there are any questions.

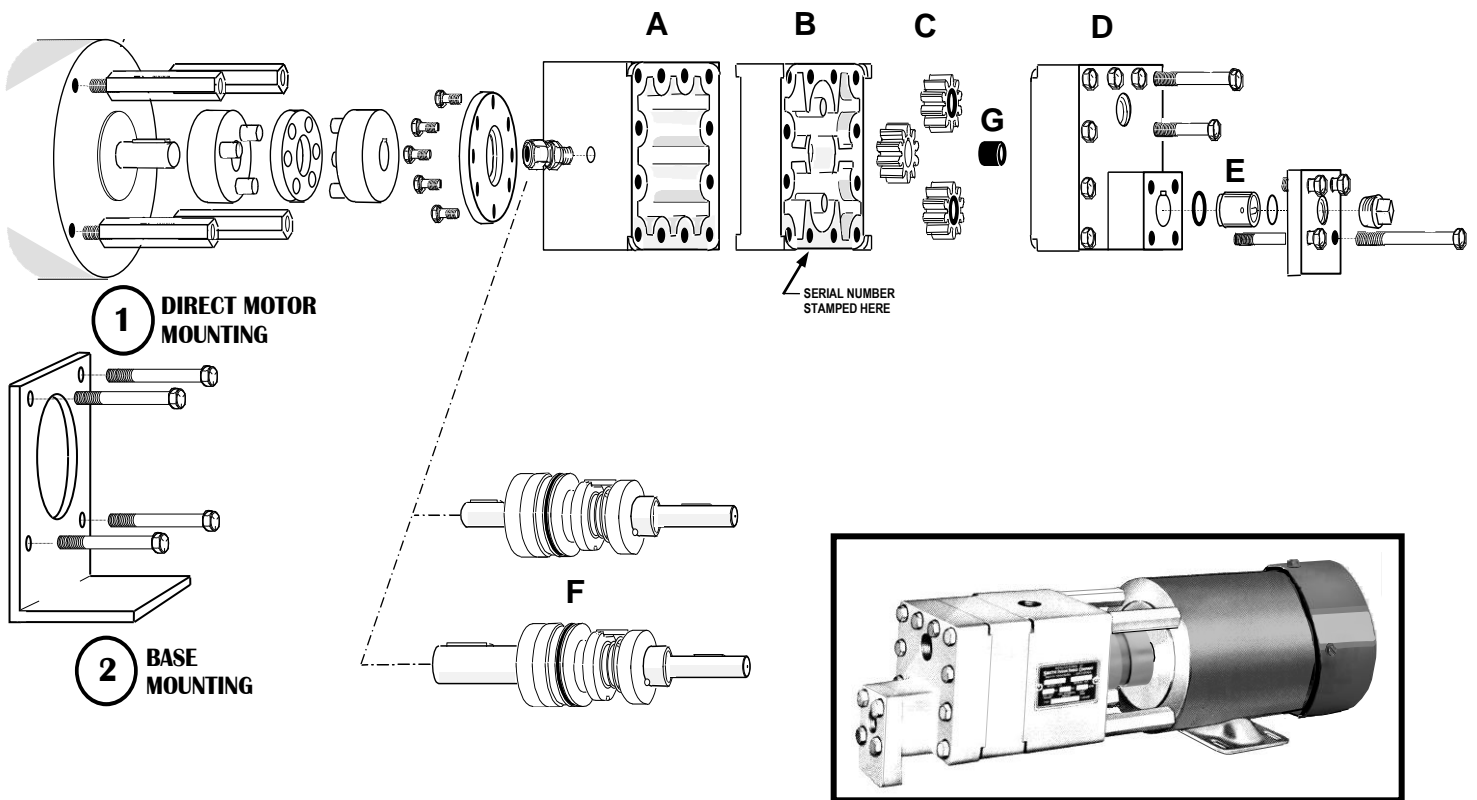
10. **Later Inspections.** No changes. Add "AL-31", and "AL-34" to the list of recommended literature. Check for subsequent casing wear in items (B) and (D) in the illustration, below.

SMITH "SQ-SERIES" PUMP MOUNTED TO A FRACTIONAL HP MOTOR
