**PREVENTIVE MAINTENANCE INSPECTION PLAN FOR  
MC-1 AND GC-1 SERIES SMITH PUMPS**

This bulletin is a supplementary addendum, which must be read in conjunction with Technical Bulletin "AL-19", and Manual "GM-1". All information listed herein, is in the same numbered section order as detailed in "AL-19". It is applicable to MC-1 and GC-1 Series pumps, as well as medium and high capacity Smith pumps, with the exception of what is stated, below. Always disassemble and reassemble the pumps in a safe, approved manner following all applicable instructions in "AL-19", "GM-1", and other literature such as "AL-1", "AL-17A", "AL-45" (N<sub>2</sub>O), "AL-99", and "AL-201". Reseal the casings properly. Contact the factory if there are any questions.

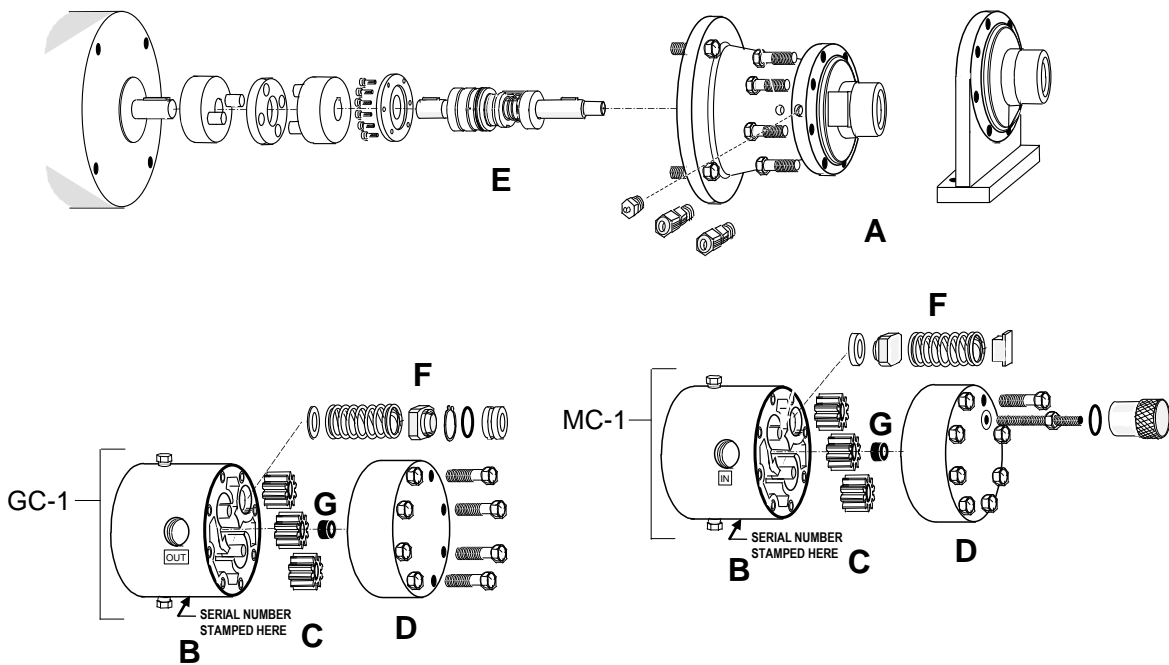
3. **Inspection of Idler Gear Bushings.** MC-1 and GC-1 Series pumps each have two idler gears per set (C) as illustrated on the following page. The proper i.d. of the carbon-graphite idler gear bushings in all idler gears after installation is 0.378 inches (9.60 mm.). If the sizes as measured do not exceed 0.379 inches (9.63 mm.), there has been very little wear and the bushings need not be replaced. If the sizes as measured exceed 0.379 inches (9.63 mm.) after such a short first interval of use, it will be important to examine the piping system and its operation to find the cause of such wear, which is excessive. When the idler gear bushings have worn to a diameter approaching 0.381 inches (9.68 mm.) or greater, the complete gear set must be replaced.

4. **Inspection of the Gears.** The proper width of new MC-1 and GC-1 Series gears (C) is 0.747-0.748 inches (18.97-18.99 mm.). Used gears measuring greater than 0.746 inches (18.95 mm.) can be reused (see gear inspection procedure in repair manual "GM-1").

5. **Recommended Procedure if Excessive Gear Wear Is Detected.** No Changes.
6. **Inspection of Idler Gear Shafts.** The proper diameter is 0.375 inches (9.53 mm.). If the measured diameter of a worn area is less than 0.374 inches (9.50 mm.) the shafts assembled in (B) as illustrated on the following page, must be replaced.

8. **Main Shaft Bushing.** The main shaft bushing (G), "649-11" is installed in the gear end cover ("D"). This carbon-graphite "journal bearing" will crack if tapped into position. It must be pressed into place, and will then acquire the proper internal diameter, 0.378-0.379 inches, or 9.60-9.63 mm., as long as the corresponding bore is not overly enlarged. Bushings with visually detectable discrepancies such as one-sided wear patterns, discolorations, or circumferential cracking, must always be replaced. There should be at least 0.002-0.003 inches (0.05-0.08 mm.) clearance between the internal shaft end diameter, and the i.d. of the corresponding bushing. If the main shaft bushing measures greater than 0.380 inches (9.65 mm.) it should be replaced.

10. **Later Inspections.** No changes. Check for subsequent casing wear in items (B) and (D) in the illustration, below. See Manual "GM-1" for additional information on this and all other related aspects of concern in this procedure.
