ED-1
(Rev. D)

Repair Manual for E and D-series Small Capacity Pumps

This manual contains valuable repair information for the DW-1Z, DW-HZ, EG-1Z, and EC-HZ pumps and describes how to change a mechanical shaft seal assembly, gear set, and bypass valve cartridge.

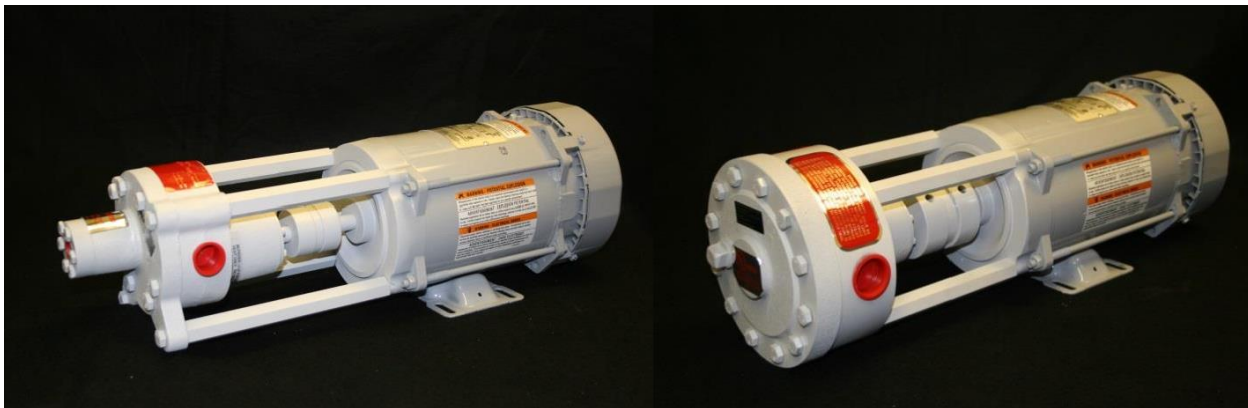
D-series Pump

E-series Pump

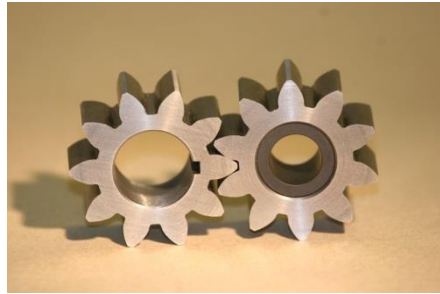
From left to right: EG-5 Drive gear, EG-6 Idler gear

Depending on the pump, the repair kits for each model contain different shaft seal assemblies and gears. For the DW-1Z and EG-1Z pumps, a repair kit consists of an E-100Z shaft seal assembly, one EG-5 drive gear, and one EG-6 idler gear.

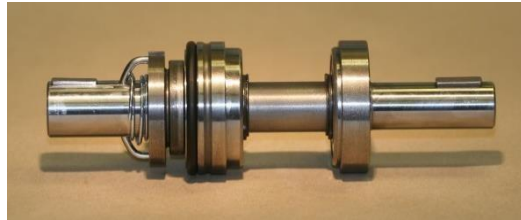
E-100Z Shaft Seal Assembly

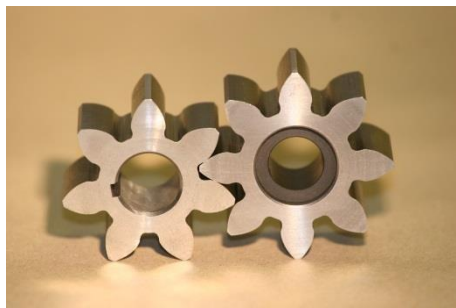
From left to right: EC-5H Drive gear, EC-6H Idler gear

For the DW-HZ and EC-HZ pump models, a repair kit consists of an E-100HZ shaft seal assembly, one EC-5H drive gear, and one EC-6H idler gear. Note the difference in the diameter of the drive shaft between the E-100Z and E-100HZ shaft seal assemblies.

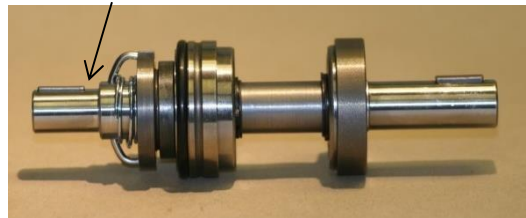
Note: smaller diameter for the E-100HZ shaft seal assembly when compared to the E-100Z

E-100HZ Shaft Seal Assembly

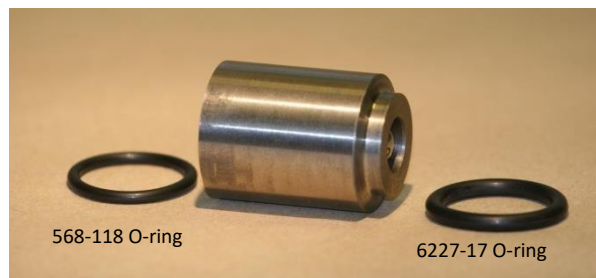
568-118 O-ring

6227-17 O-ring

E-20 Bypass Valve Assembly w/O-rings

All four of these model pumps utilize the same bypass valve cartridge, the E-20 which contains 2 O-rings, the 6227-17 and the 568-118. Older E series pumps may use the E-20H cartridge, a larger version which was discontinued in 1987 for the EC-HZ pump model. If you are replacing an E-20H bypass valve cartridge please contact the factory. See the following pictures and assembly drawings PI-1 and PI-10 attached for reference.

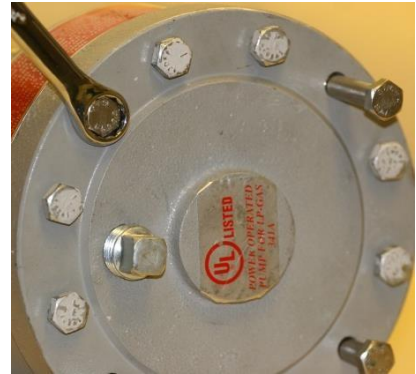
Remove 4 cap screws to separate the pump from the motor

Separate the pump and motor. Four bolts hold the pump onto the motor and are screwed into the mounting spacers. These bolts can be loosened and removed from the pump cover side. The pump can remain in the pipework.

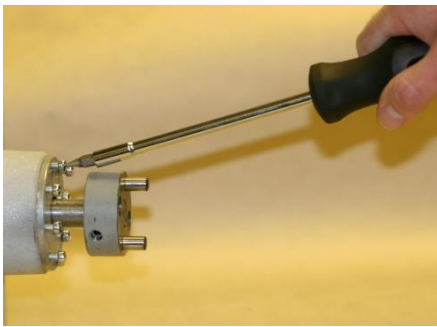
Removal of bearing retainer plate (E-15) held in by 8 head screws

Remove the small screws from the bearing retainer plate at the shaft end of the pump and rotate the shaft so the coupling key is at the 12 O'clock position.

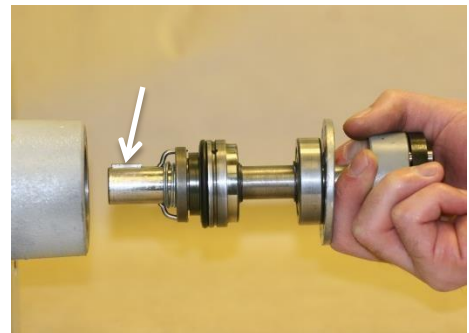
Shaft seal assembly removed with key in 12 O'clock position

Pull the shaft straight out of the pump. As an aid in removing the shaft seal assembly, the pump coupling half may be left on the pump drive shaft. What comes out is the shaft seal assembly comprised of two ball-bearings, the seal components and an o-ring, all attached to the drive shaft. This is what we call a shaft seal assembly. Make sure the o-ring comes out as well as the shaft assembly. Remove the pump coupling half if it was left on the pump drive shaft. Refer to PI -1 and PI-10 for reference.

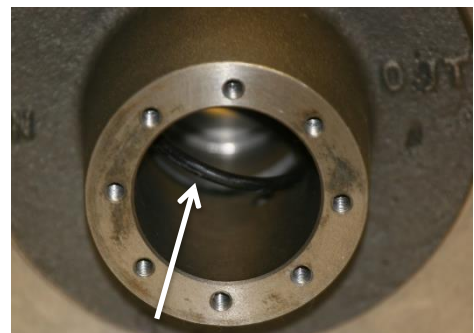
Remove the 6227-17 O-ring. The replacement shaft seal assembly comes with a new, replacement o-ring.

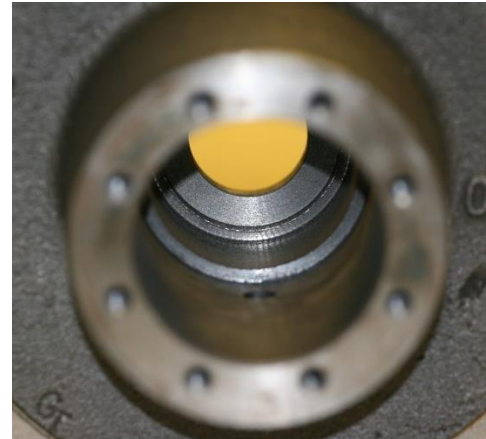
Main housing where shaft seal assembly and bleeder hole is located

Closely examine the inside of the main housing where the shaft seal assembly came out of. Because there is a bleeder hole in this area, normally grime, rust, or dirt becomes lodged here. Carefully remove the debris and clean as best you can.

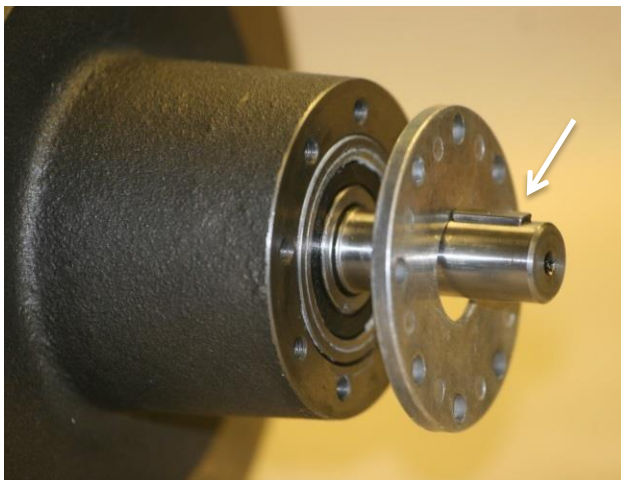
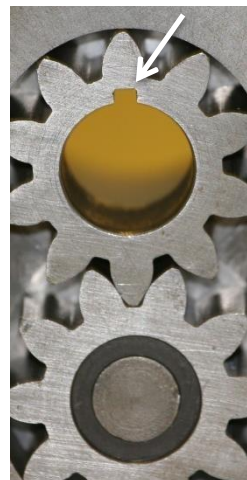
Replacement shaft seal assembly inserted into main housing with key in 12 o'clock position to fit drive gear keyway also in 12 o'clock position

Apply a **small** amount of grease to the inside of the pump housing where the shaft seal assembly will be installed. This will make the installation easier. Never use oil or WD-40 type lubricants. Now slide the replacement seal assembly into place. Make sure that the coupling key is in the 12 O'clock position. This recommendation is made so that the replacement mechanical seal will slide easily through the keyway in the drive gear which cannot be seen. When sliding in the replacement shaft seal assembly and resistance is felt, this means that the drive gear key does not quite line-up with the keyway in the drive gear. If this happens, rotate the shaft a little each way while gently pushing the shaft seal assembly in until the key is felt to enter the drive gear keyway. Then push the shaft seal assembly the rest of the way in. Do not use a hammer to drive the replacement seal in place. If the shaft seal assembly cannot be installed as above due to too much resistance, this may indicate a severely worn-out gear set. Refer to the second part of this manual entitled FOR A GEAR SET REPLACEMENT and follow all steps to replace the gear set.

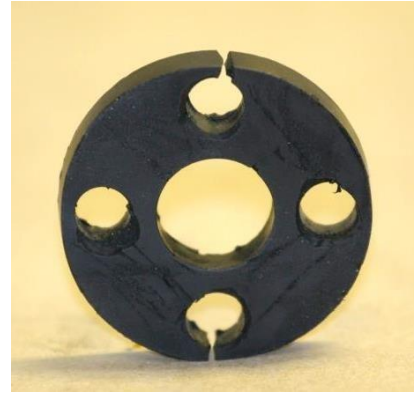
Damaged FD-20 Coupling Insert

Now replace the bearing retainer plate, screws, and coupling half. Also, this is a good time to inspect the flexible drive coupling insert. If it is damaged, or the coupling halves are damaged, replace them.

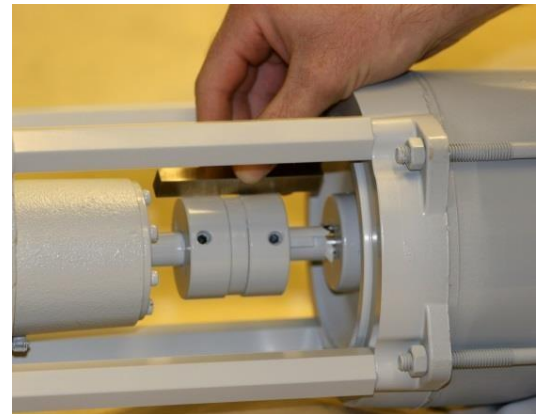
Proper Coupling Alignment using Straight Edge

Bring the motor back in contact with the pump, align the coupling and insert the mounting spacer bolts. Tighten these bolts. For proper coupling alignment between motor and pump shafts, lay a straight edge over the tops of the two halves as shown. Do not sandwich the coupling insert tightly between the two halves or leave space between the halves and insert. The coupling halves should be just making contact with the insert.

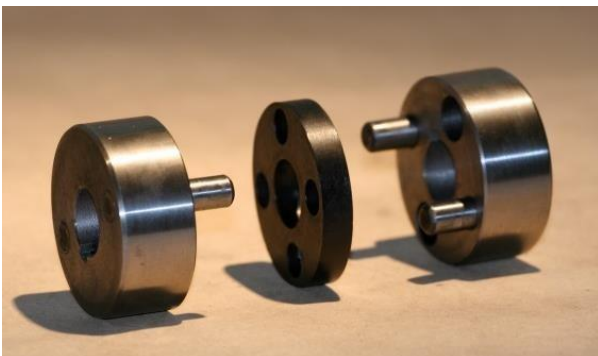
VC-20 Coupling with FD-20 Insert

For EG-1, DW-1, and DW-H series pumps, a Smith VC-20 coupling with an FD-20 insert is recommended.

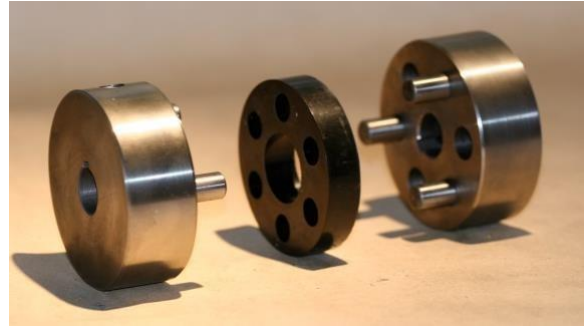
VC-30 Coupling with FD-30 Insert

For EC-H series pumps, a Smith VC-30 coupling with an FD-30 insert is recommended.

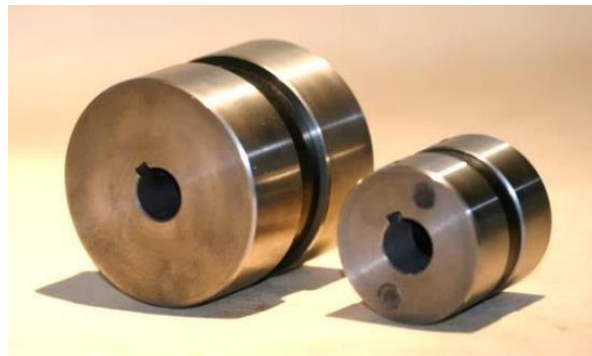
From left to right: VC-30 coupling with FD-30 insert next to VC-20 coupling and FD-20 insert

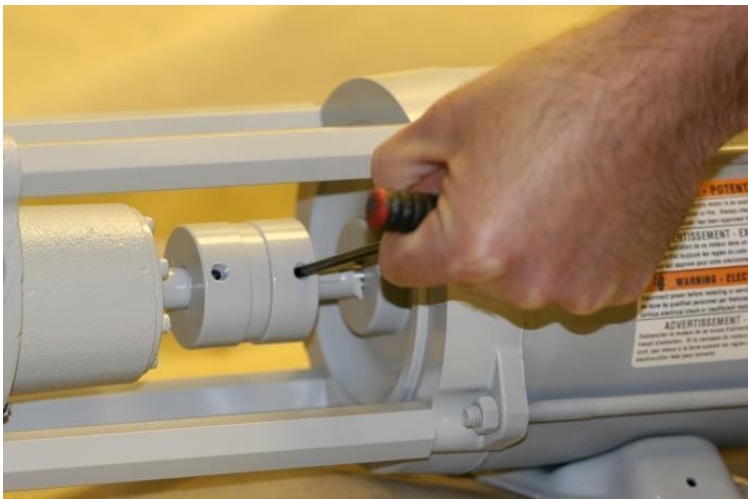
Tightening of coupling set screw using allen wrench

Tighten the coupling set screw and rotate the pump shaft to make sure it turns freely.

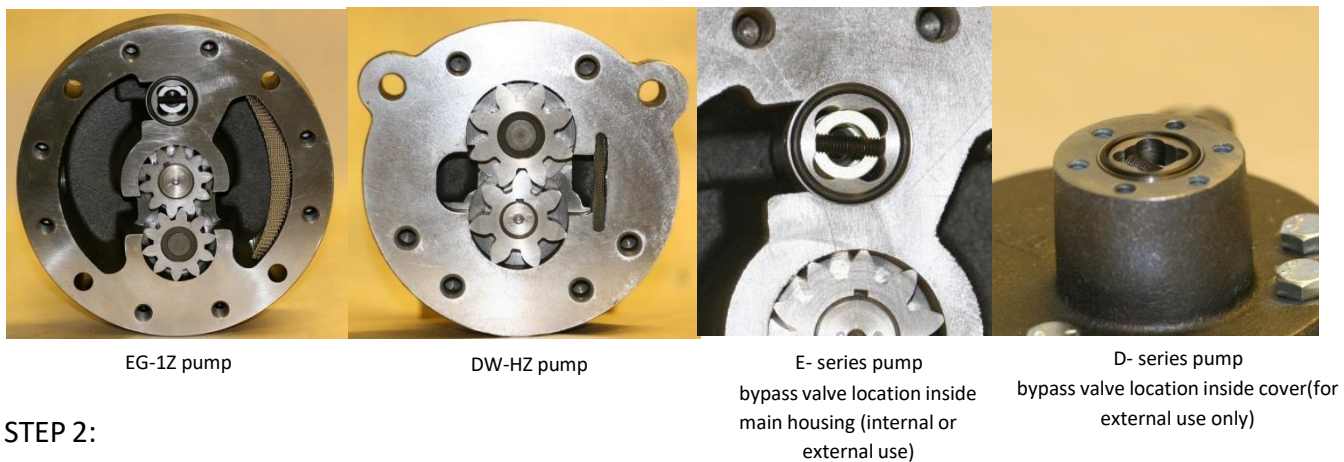
While leaving the pump in the depressurized pipework, remove all of the bolts that hold the pump cover onto the main housing, including the mounting spacer bolts, and remove the cover. Once removed, you will see the gear set and built-in strainer screen. For the EG-1Z and EC-HZ, the bypass valve cartridge can also be seen in the main housing along with the drive gear above the idler gear. For the DW-1Z and DW-HZ, the bypass valve cartridge is housed in the pump cover and the drive gear is below the idler gear in the main housing. For more details, refer to PI-1 and PI-10.

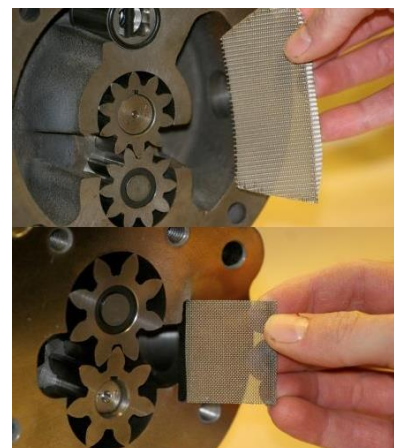
E-21 built in strainer screen for
E-series pumps

Remove the built in strainer screen. The strainer screen for the EG-1Z and EC-HZ pumps is larger than the screen used for the DW-1Z and DW-HZ pumps. Clean and remove any particles within the screen that have been trapped over time.

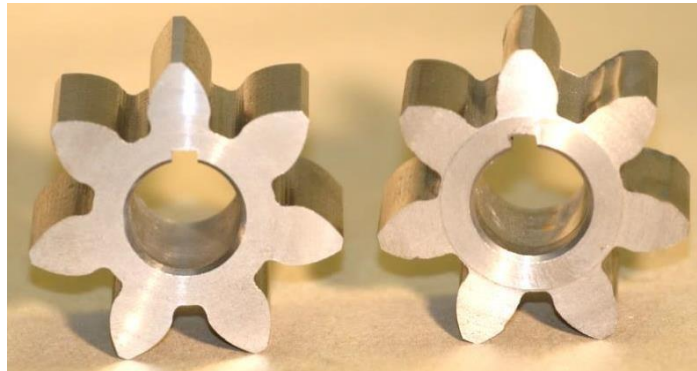
From left to right: A gear with no wear, a worn out gear that needs replacement

This step involves an inspection of the gear set. Carefully inspect the gear set for wear. Any wear that appears obvious means that the gear set must be replaced. Take a look at the gear tooth profile. It should be symmetric and follow a convex curve from the tip of the gear tooth to the root of the gear. If it does not, the gear should be replaced. If there is significant wear along this profile, the gear should be replaced.

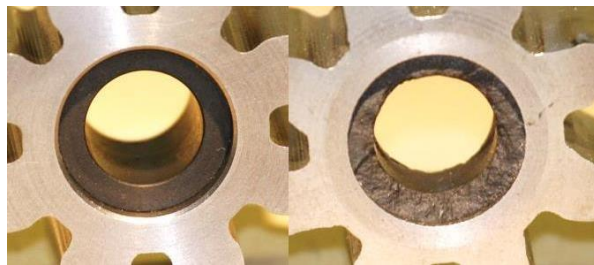
From left to right: Idler gear bushing that has no wear, gear/bushing that needs replacement

Inspect the bushing pressed into the idler gear for signs of eccentric wear. The internal bore of this bushing should be a perfect circle and smooth. If it is not, either the bushing or idler gear should be replaced.

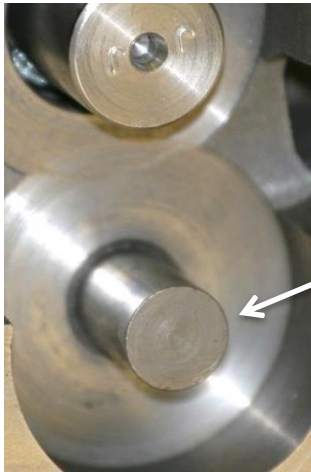
Gear pocket in good condition

Before installing a new or used gear set, the pockets and cover should be inspected for unusual wear. Carefully look at the gear pocket sides to determine if any wear has occurred. You are looking for any obvious gouge marks, uneven wear patterns, etc. Also, inspect the bottom of the gear pockets for the same signs of significant wear.

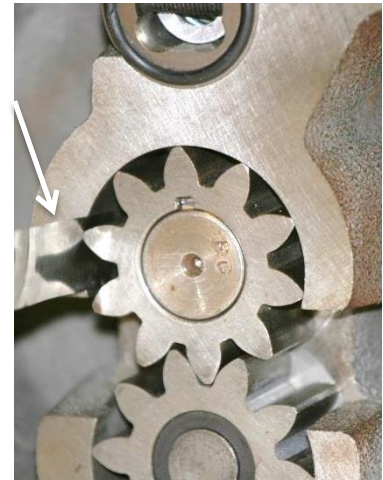
Feeler gauge check

To see if any of this unusual wear has occurred, install a new idler gear over the idler gear shaft (E-9) and place a feeler gauge in between the outside diameter of the gear and the gear pocket. Do the same for the drive gear over the drive shaft. If a **0.004** feeler gauge or higher can be placed into this space, then the gear pocket is worn excessively and either the main housing should be replaced or the pump should be exchanged.

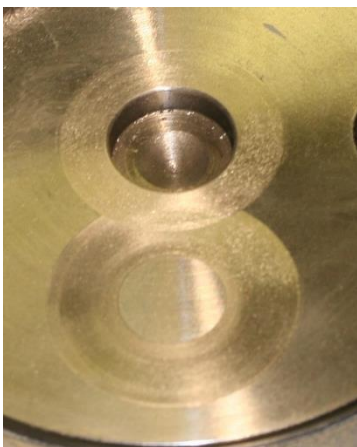
Normal cover gear contact rings;
cover can be reused again

In a similar fashion, the cover (E-2 or D-2) should also be inspected for wear. Normally, the gear set will leave circular contact rings on the cover. The cover should only be replaced if these contact rings are deep and felt by running your thumbnail over them.

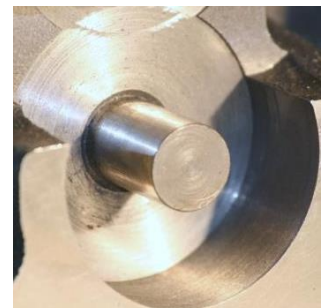
Idler gear shaft in good condition

Also, inspect the idler gear shaft that supports the idler gear. While this shaft rarely must be replaced, check for obvious signs of damage.

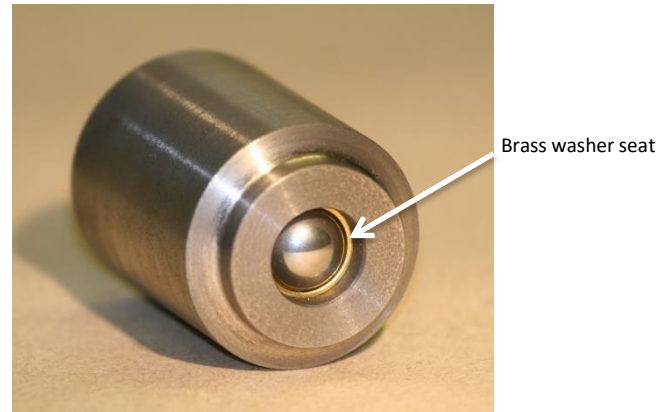
E-20 bypass valve used in E and D series pumps

The bypass valve cartridge should also be inspected. A good rule of thumb when deciding to replace the cartridge or not is to always replace if the pump is **10 years old or older**. Look at the bottom of the cartridge where the ball seats on the brass washer to make sure that debris has not lodged between the ball and the washer. This will allow pumped product to continually circulate through the cartridge and will cavitate the pump if used for internal bypass. If debris is found, lift-up the ball and blow the debris away. If the cartridge appears to be damaged in any way, it should be replaced. If the cartridge is to be reused always replace the old o-rings with 2 new o-rings (6227-17 and 568-118). See PI-1 and PI-10. Note: For older EC-HZ pumps manufactured before 1987, the larger E-20H bypass valve was discontinued. Contact the factory for more information.

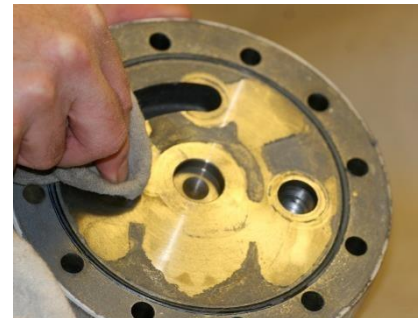
Old sealant being removed; a razor blade or any lubricant such as WD-40 can be used

Before replacement parts are installed in the pump, all old sealant left on the face of the pump main housing and cover (E-2 or D-2) must be removed. This is important as old sealant can lift the pump cover enough so slippage occurs within the pump and could cause cavitation.

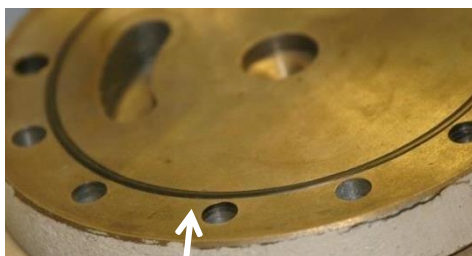
6230-28 O-ring

Replace the cover o-ring (6230-28 for E-series, 6230-14 for D-series); do not reuse the old one.

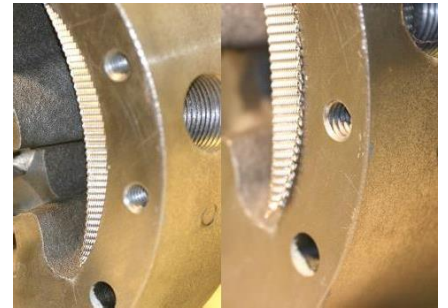
Correct installation

Wrong installation
(wire above surface face)

Install the strainer screen making sure that the wire strands are below the surface of the pump main housing face and tucked securely into the inlet pocket. If one wire strand lies on top of the cover face, the cover could be lifted up enough so that slippage will occur in the pump, resulting in cavitation and poor pump performance.

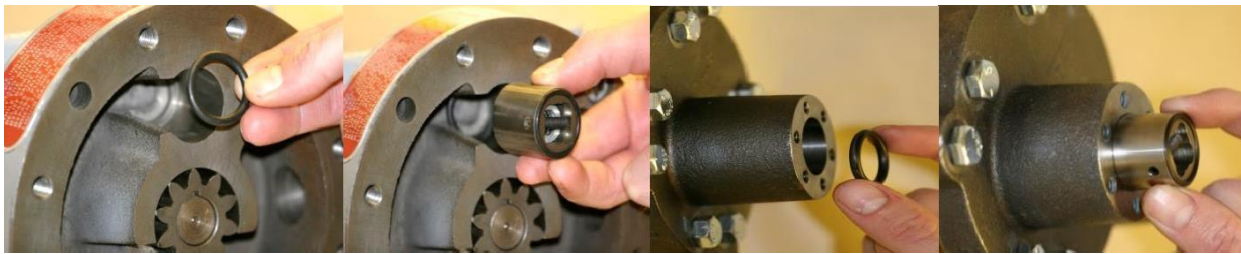
6227-17 o-ring inserted first into E-series main housing

E-20 cartridge with 568-118 o-ring into E-series main housing

6227-17 o-ring inserted first into D-series pump cover

E-20 cartridge inserted into D-series pump cover

Install the bypass valve cartridge with 2 new o-rings; one for the top and bottom. (See PI-1 or PI-10). Do not reuse old o-rings. The bypass valve cartridge is installed in the cover (D-2) for the DW-1Z and DW-HZ pumps and in the main housing for the EG-1Z and EC-HZ pumps.

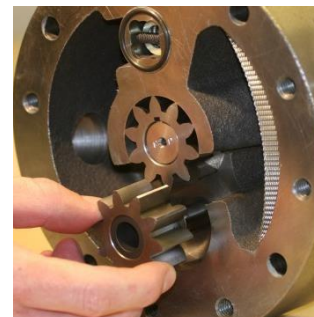
EG-6 idler gear installed after EG-5 drive gear

Install the gear set. Do not hammer them into place. The drive gear can only be installed in one way. Best practice is to install the drive gear first. Simply slide the drive gear over the pump drive shaft so that the key engages inside the drive gear keyway. Push the drive gear all the way down the drive shaft until it stops. Likewise, install the idler gear over the idler gear shaft.

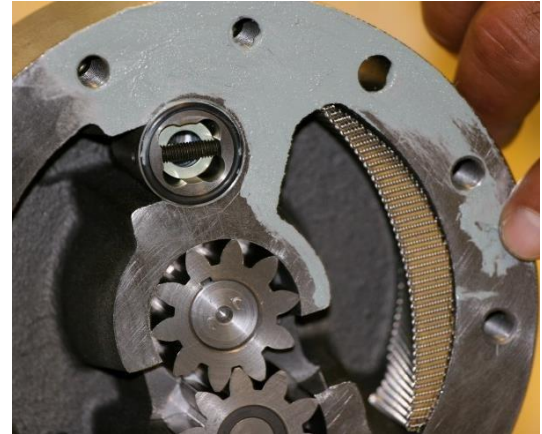
PLS #2 Sealant being applied to main housing, not cover

After all of the above replacement parts have been installed as outlined above, PLS#2 or Gasoila Soft-Set, Teflon based sealant should be applied to the face of the pump main housing only. Never apply sealant to the cover, gears, bypass valve cartridge, or shaft seal assembly. The old sealant from the cover and main housing should be removed per STEP 6. Caution: The sealant should be applied very sparingly and only smeared on with a very thin layer. If the sealant is over-applied, the excess may enter the gear pockets and cause damage or pump seizure.

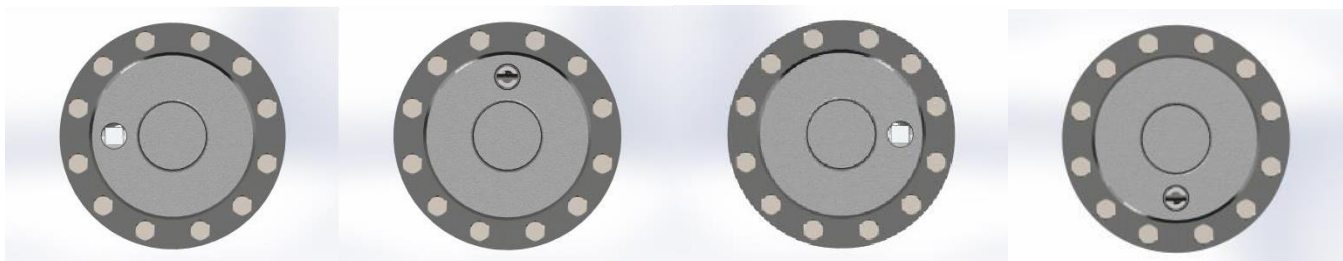
9 O'clock
(plug in place, internal bypass)

12 O'clock
(plug removed, external bypass)

3 O'clock
(Pump upside down with plug in place, internal bypass)

6 O'clock
(Pump upside down with plug removed, external bypass)

With the cover o-ring replaced, bolt the cover onto the main housing. Be careful here to install the cover in the same position it was when removed from the pump main housing. A 1/2 -inch tapped hole exists in the cover for the EG-1Z pump and a 3/4- inch tapped hole for the EC-HZ pump. This hole may have a plug in it or may be used to pipe back to the vapor space of the supply tank. Make sure the cover is reinstalled so that this hole is located in the same position it was when the cover was removed. Chances are if the cover has a pipe plug in it, the cover can be reinstalled so that the plug is in the 9-O'clock position. If the cover does not have a plug in it but was used to pipe back to the supply tank, the cover can be reinstalled in the 12-O'clock position. This assumes that the pump was not mounted to the motor upside down. If the pump was mounted upside down then the cover must be reinstalled at the 3-O'clock position if it has a pipe plug in it or at the 6-O'clock position if piped back to the vapor space of the supply tank.
